## Full-scale test of glazing for stairs in theatre

The project of the Mariinsky theatre of Saint-Petersburg new building includes stairs with glass steps and balustrades. The audience passage could provide very large loads to theatrical stairs, so designers decided to carry out some full-scale tests of glass steps and side balustrades, which were produced according to design plans in full-size. Projects participants developed special test program taking into account safety rules acting both in Russia and in Europe. Tests were specific in conditions. Sizes, shapes and fastening of the samples were very different from described in standards for impact and deflection tests. That led to some new interesting results.

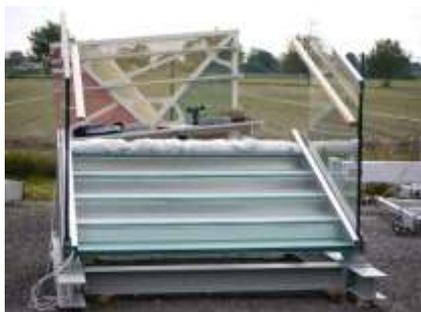
Figure 1. The stair mock-up with specimens installed: “Step 8.15.15.8” (lowest one), “Step 8hs.12hs.12hs.8hs” (other steps) and “Barrier 12t.12t” (barrier glazing).

- Laminated glass steps with heat-strengthened glass layers in the following composition: outside layer of 8 mm thickness, two intermediate 12-mm layers, inside 8-mm layer. Size of all such samples was 2000×400 mm. Glass layers were laminated with ionoplast polymer films. Specimens supported along two short sides. These specimens were marked “Step 8hs.12hs.12hs.8hs”. See Figure 1 for the mock-up with the installed specimen's picture.

- Laminated glass steps with annealed glass layers in the following composition: 8-mm outside glass, two 15-mm intermediate layers and 8-mm inside glass. These specimens had the same sizes like listed above but during the tests, they were installed on the supports with 1700-mm wide gap to show real distance between the supports in the project of the stair. Laminated glass in this case included 1.52-mm-thick PVB foil. These specimens were marked “Step 8.15.15.8”.

- Laminated glass barrier, parallel shaped and consisted of two tempered glass layers, 12 mm thick each. Sizes were 1600 (length) × 1275 (height) mm, PVB foil was 1.52 mm thick. Installed specimens were supported by clamping along bottom edge. We marked these specimens as “Barrier 12t.12t”.

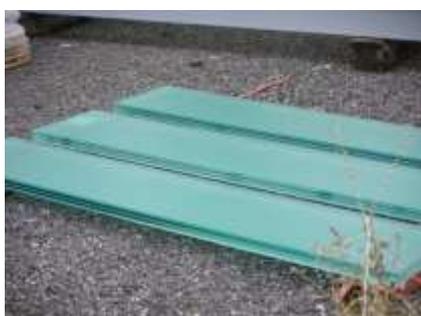
Figure 2. The specimens marked «Step 8.15.15.8 № 1, 2, 3».

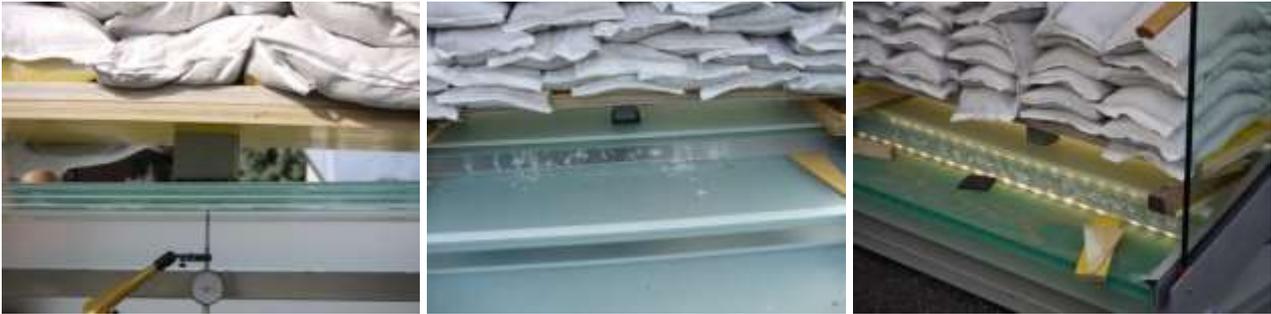
Figure 3. Concentrated load test for “Step 8hs.12hs.12hs.8hs № 1, 2 and 3” specimens.

All static load tests were carried out with the help of 15 liters volume sandbags and plywood panels. Total load for the concentrated load test was 600 kg; total load for the uniformly distributed load test was 480 kg. Concentrated load test also used steel cubes and plastic gaskets. Designers decided to start with concentrated load test, which is harder test than uniformly distributed test, and we agreed with that decision. Figure 3 consists of “Step 8hs.12hs.12hs.8hs” specimen’s photos on the moments of ending of load exposure time. All “Step 8hs.12hs.12hs.8hs” withstood the test without breakage. Maximum of the deflection in this test was 8.76 mm.

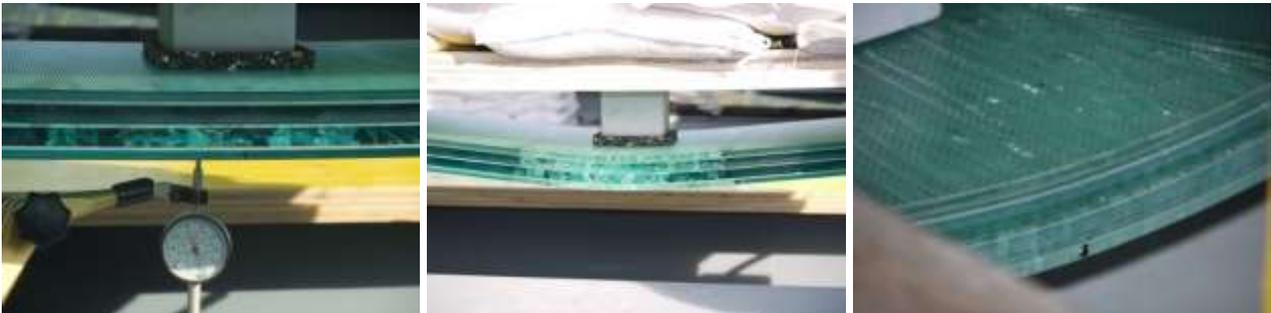
Figure 4. Concentrated load test for “Step 8.15.15.8 № 1 and 3” specimens.

When we applied concentrated load of 600 kg to the “Step 8.15.15.8 № 1”, it broke up after 23 minutes. The result repeated with “Step 8.15.15.8 № 3” after 25 minutes of load exposure. In both cases breakage started from 15-mm thick glass layer. Only “Step 8.15.15.8 № 2” withstood the test, maximum deflection was 18.90 mm which is much higher than we saw in the case of heat-strengthened samples with ionoplast lamination films.

Results of these test section you can see on Figure 4.

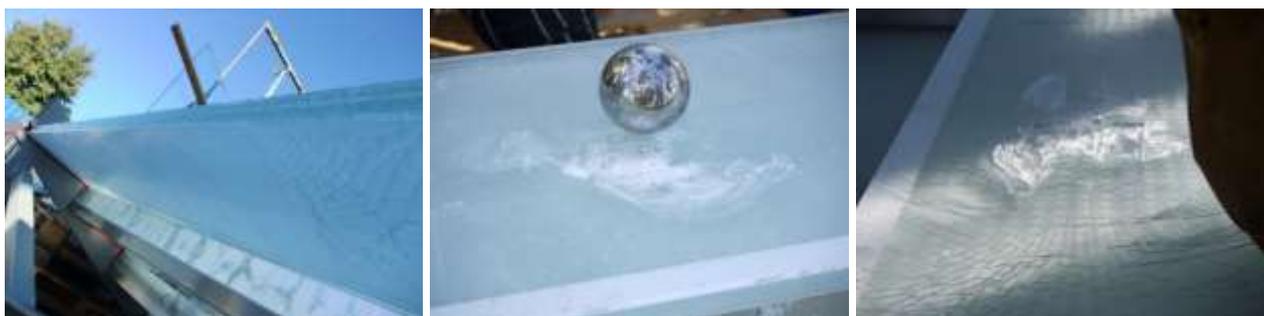
Figure 5. Some photos of hard body impact test for “Step 8hs.12hs.12hs.8hs” specimens.

Again all specimens “Step 8hs.12hs.12hs.8hs” withstood both stages. We noted that tests damaged only two outside layers of glass. Some results of this stage of test you can see on the photos from Figure 5.

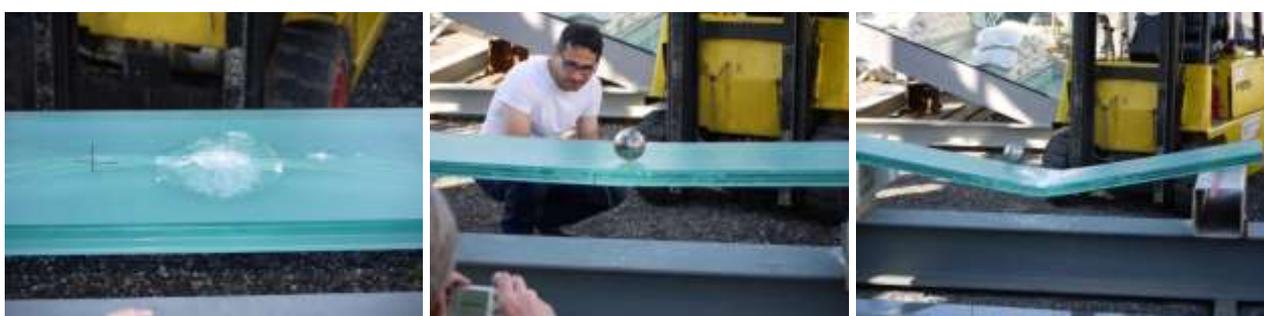
Figure 6. Some photos of hard body impact test for “Step 8.15.15.8” specimens.

Very different results were with “Step 8.15.15.8” specimens. Although they withstood ball hits, all of them were hardly damaged. Application of the smallest part of uniformly distributed load broke them finally as you can see on the Figure 6. Just one ball hit broke two glass layers in the “Step 8.15.15.8 № 2” and all 4 glass layers in the “Step 8.15.15.8 № 5”.

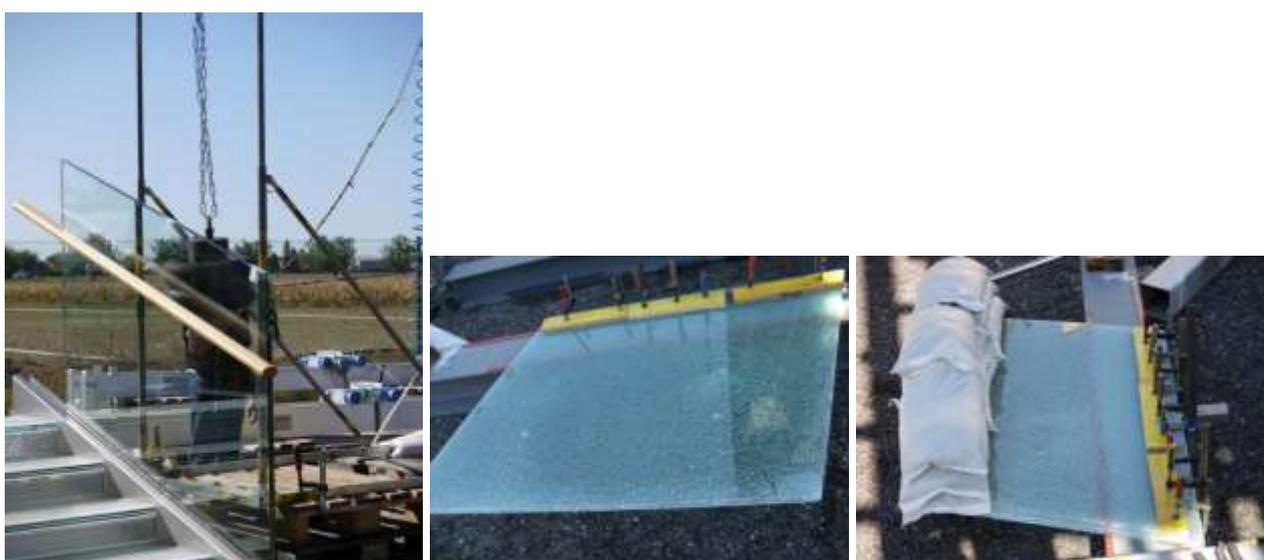
Figure 7. Tests of “Barrier 12t.12t” specimens for soft body impact and linear distributed load.

Soft body impact test for barrier glazing included one soft body drop from 1200 mm height and application of 1.5 kN/m of linear load on the glass with one broken layer during 30 minutes. The linear load applied to the horizontally positioned specimen with clamping, which supplied the same force moment as in the case of linear load application to the handrail in project installation.

Tests were successful for all “Barrier 12t.12t” specimens, so nothing can be added here except the positive reaction to the right choice of the glazing construction. Some photos from this testing we include in Figure 7.
